CROWN ESTATE PAVING COMMISSION

# Chester Terrace Management Vision

August 2019

Todd Longstaffe-Gowan  
Landscape Design

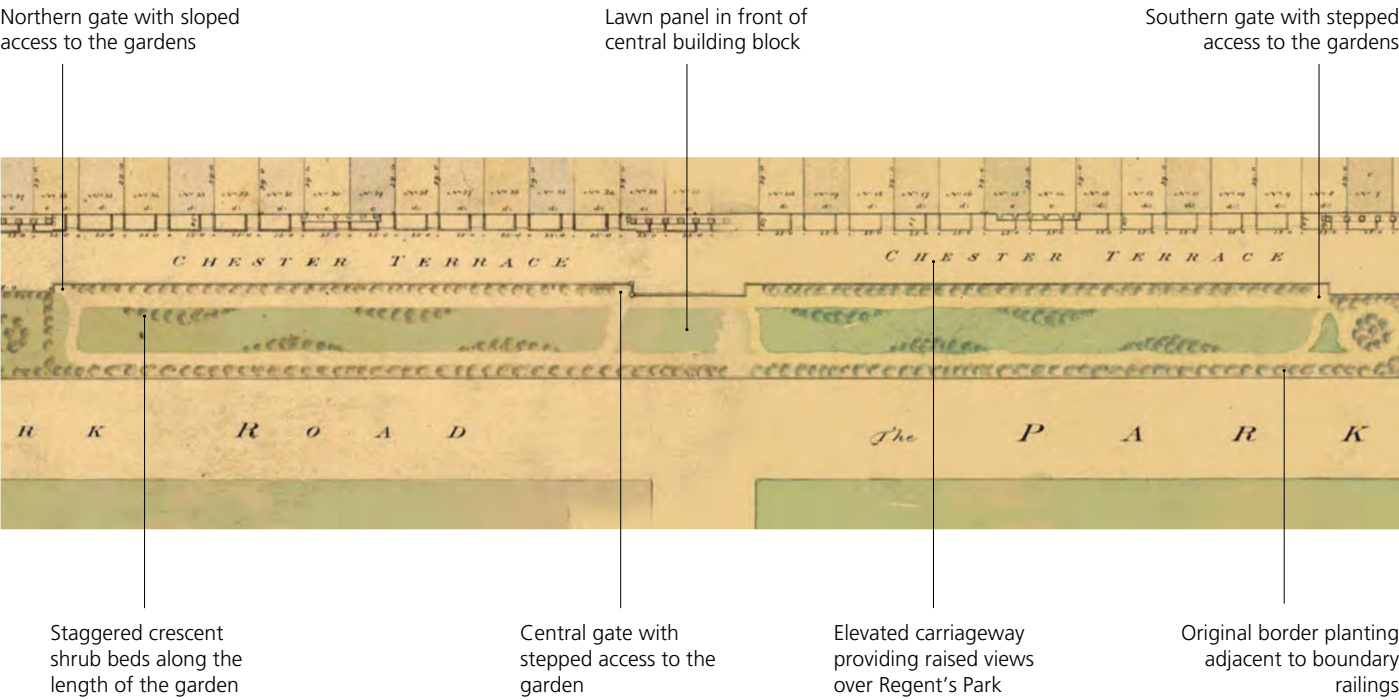
1834 Mayhew Plan (NTS)

N.B. The plan above is a montage of two original Mayhew drawings that have been joined in the centre.

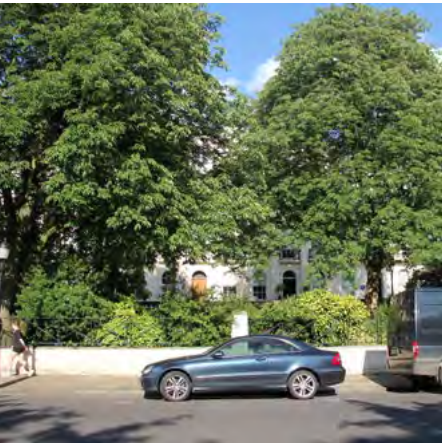
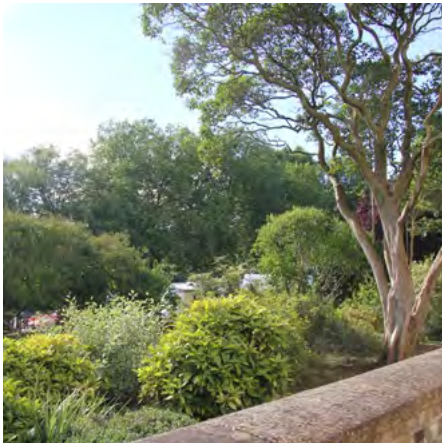
Far left: Views to Chester Terrace from the Outer Circle are completely obscured in places.

Left: Historic views from the elevated position of Chester Terrace are screened by large trees and shrubs.

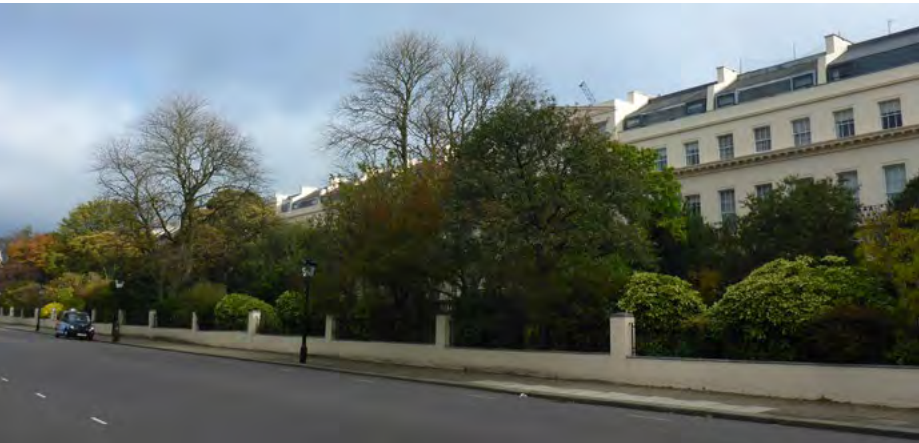
Left: Existing view from the approximate location of the Shepherd drawing above. The majority of the building facade is obscured by trees and shrubs.

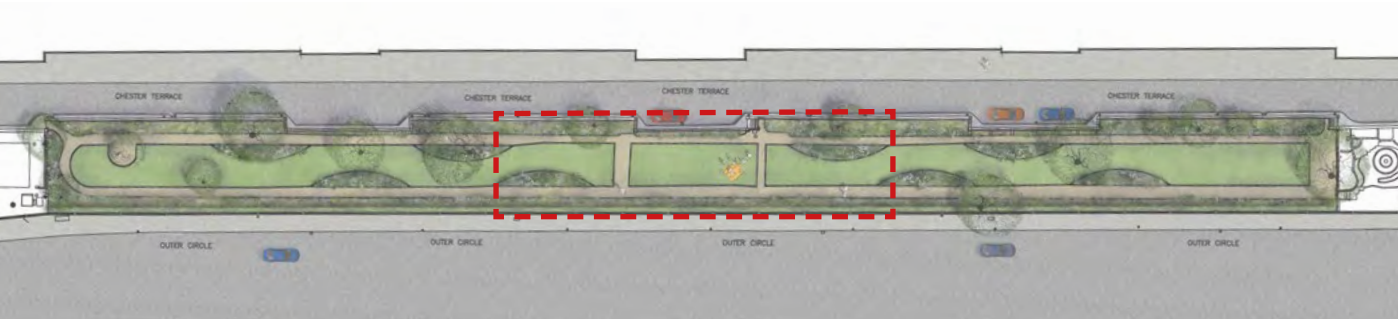
⌚ Proposed Plan (NTS)

Above: The proposed plan following the demise of the three central trees. The *Ligustrum lucidum* (Chinese privet) in the centre is not replaced, while the two flanking trees are replaced with smaller species. In this scenario, views are opened up to the central block of the building.

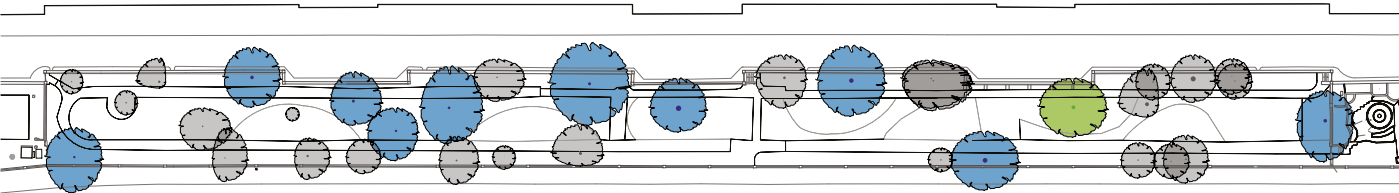
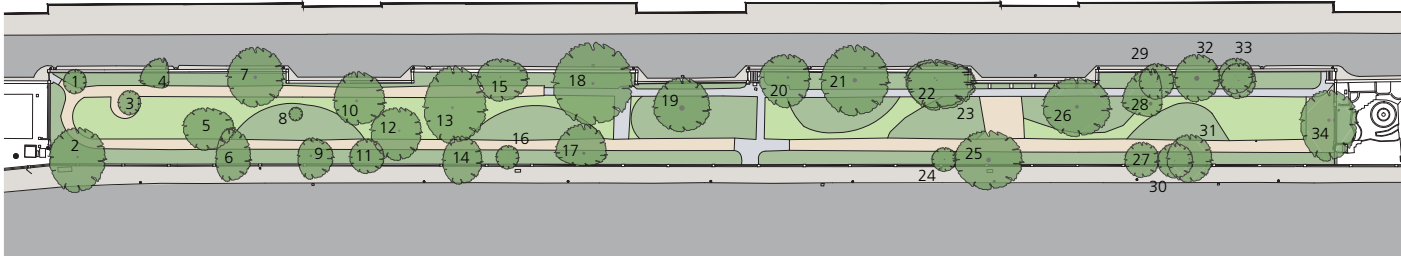
In February 2017, Mayhew Consultancy Ltd performed a comprehensive assessment of the conditions of the trees in Chester Terrace. Of the 34 trees in the terrace, the majority (23) were found to be grade C trees - unremarkable or impaired. Approximately a third were considered grade B, while only a single *Aesculus flava* (sweet buckeye) was considered of high enough merit to warrant grade A status. Two trees are no longer present on site having been removed due to ill health, therefore they have been omitted on the plans shown.

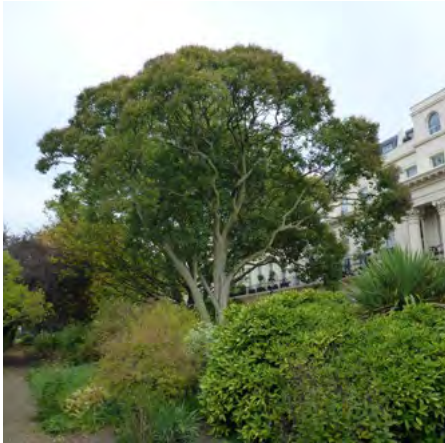
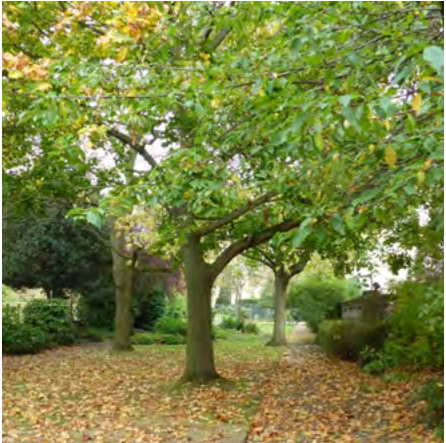
Far Right: two grade B *Acer pseudoplatanus* (sycamore) and a grade B *Catalpa bignonioides* (Indian bean tree) are growing in close proximity to one another. The crown of the *Catalpa* is impeded by the adjacent trees, both of which would benefit from its removal.

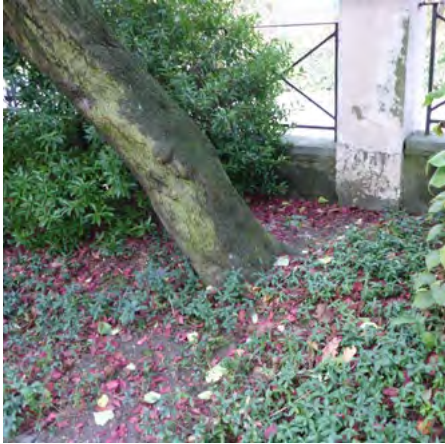
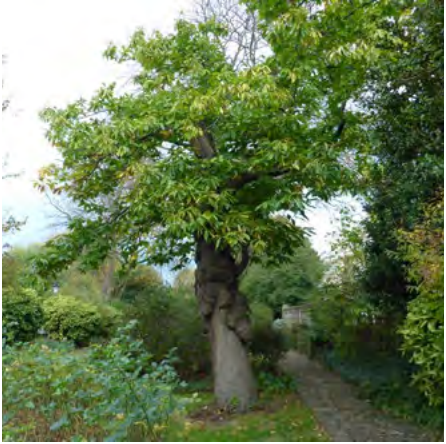
Right: Trees planted along the western boundary place unforeseen stresses on the parapet wall. Many are leaning into the garden, possibly due to an inability to anchor themselves appropriately.

Far Right: The heavily impaired *Castanea sativa* (sweet chestnut) at the south end of the garden should be removed due to decay in the main stem.

The western boundary contains a high proportion of poor trees that suffer due to being planted too close to the boundary wall. Furthermore, the weight of the trees is placing additional pressure on the footing of the structure and therefore compromising its overall strength.

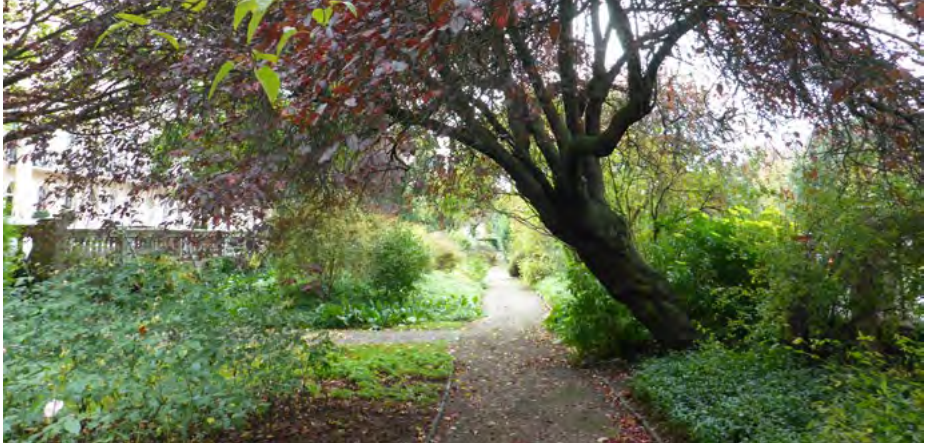
Left: An inward leaning *Prunus cerasifera* ‘Pissardii’ (cherry plum) that impedes the western path.

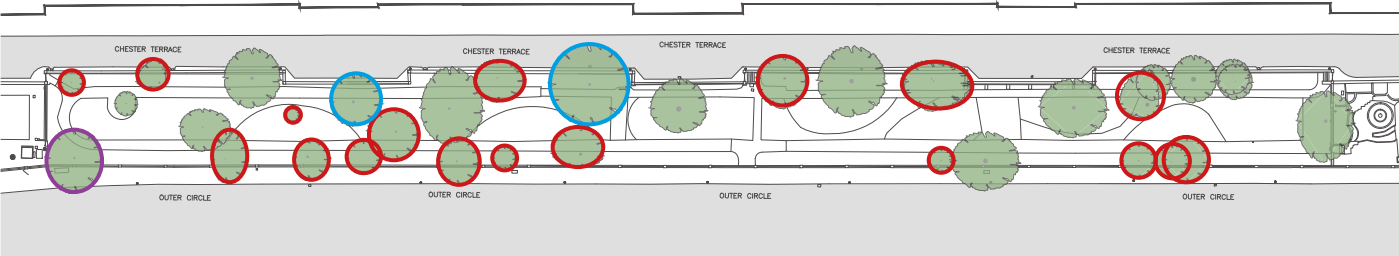
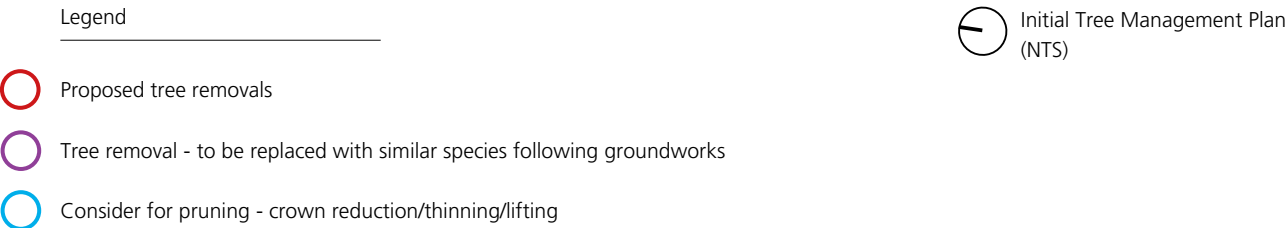
Due to the condition of the existing boundary wall, there is a need to lower the soil level on the adjacent western planting bed. The proposed level changes cannot be undertaken without adversely effecting the tree roots in this area, which would leave the trees damaged and at risk of falling. It is therefore necessary to remove the majority of the trees along the western boundary, in order to safely carry out the necessary refurbishments to the wall.

Of the trees to be removed on the western edge, all but one are grade C trees. An exception to the removals will be made in the case of the prominent grade B *Aesculus flava* (sweet chestnut), which will be retained. Any grade changes required adjacent to this tree will be undertaken following its natural demise.

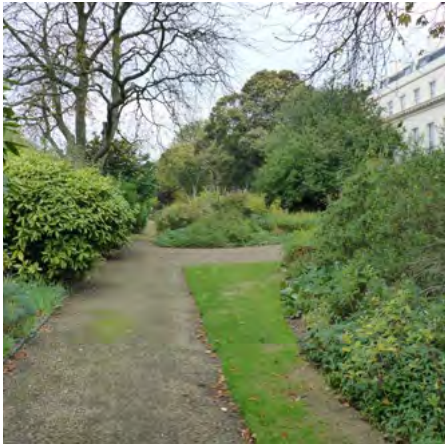
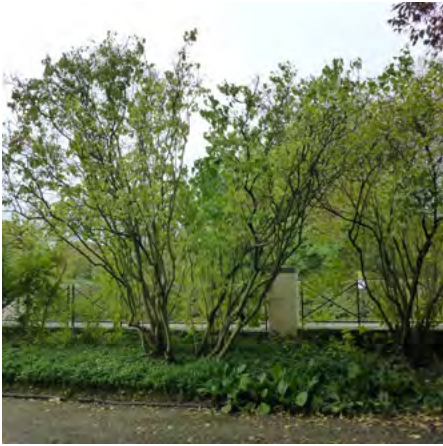
Right: Shrub and herbaceous planting is mostly well established throughout the garden.

Far Right: Many of the shrubs have become far bigger than they were intended to be, which has resulted in their “leggy” appearance. In such cases, the garden would benefit from the replacement of these shrubs with healthy mature specimens or in come cases, significant pruning to rejuvenate existing shrubs.

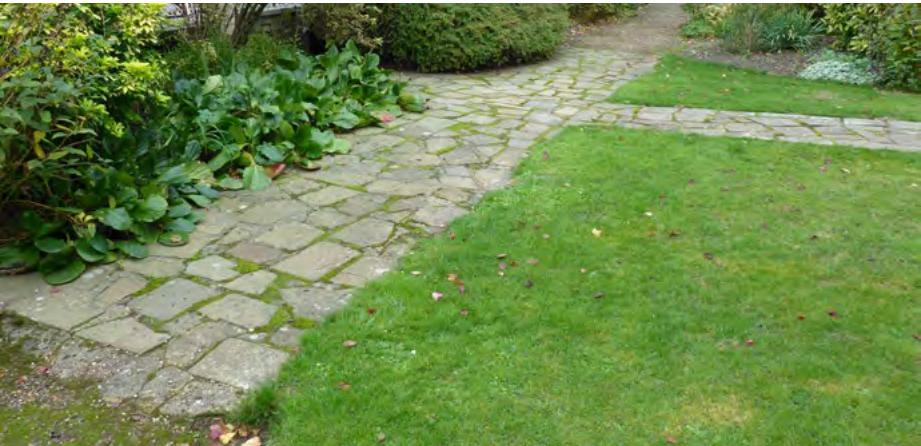
Left: Piecemeal changes to the original gravel paths have resulted in an incongruous mixture of surfaces. Sections of crazy paving are an incongruous addition to the garden that are at odds with the grandeur of the building.

Lengths of path have been replaced in a piecemeal fashion with modern crazy paving, which has resulted in the straightening of the two central crossing paths and an inconsistent surface treatment across the garden.

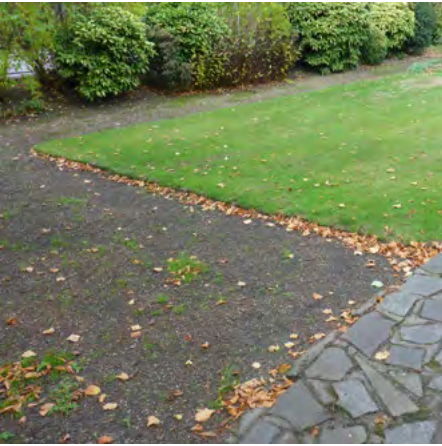
Far left: The existing gravel paths would benefit from resurfacing. Large areas of the path are down to bare earth, which has promoted the encroachment of weeds.

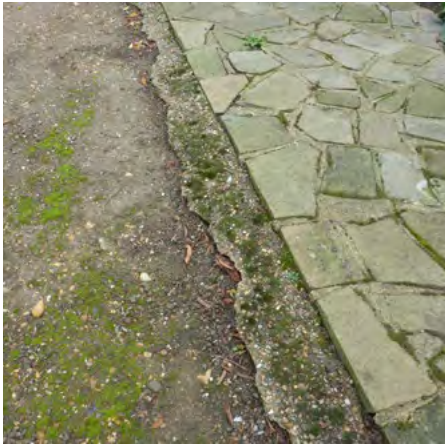
Left: When laid correctly, the gravel surface should cover the haunching to the pavement and form a level threshold to the path surfaces.

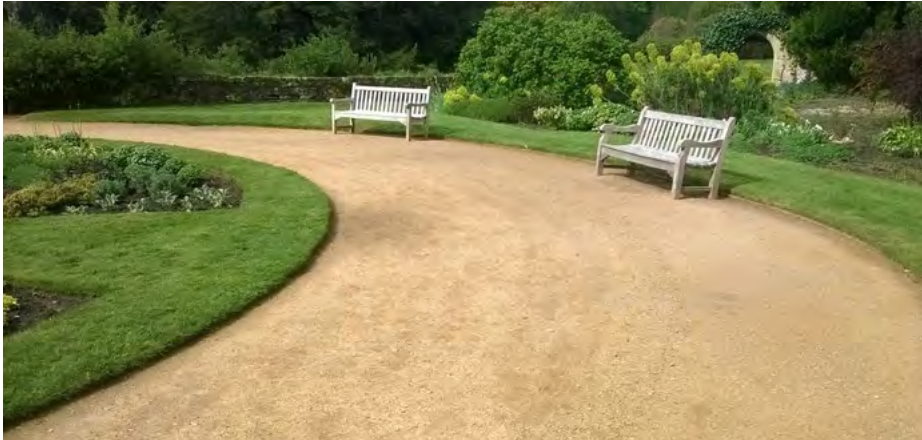
Self-binding gravel (such as that used at Scotney Castle, left) has a low particle size that allows the material to consolidate to form a smooth even surface. It is permeable, though can become less free-draining over time due to the high marl content.

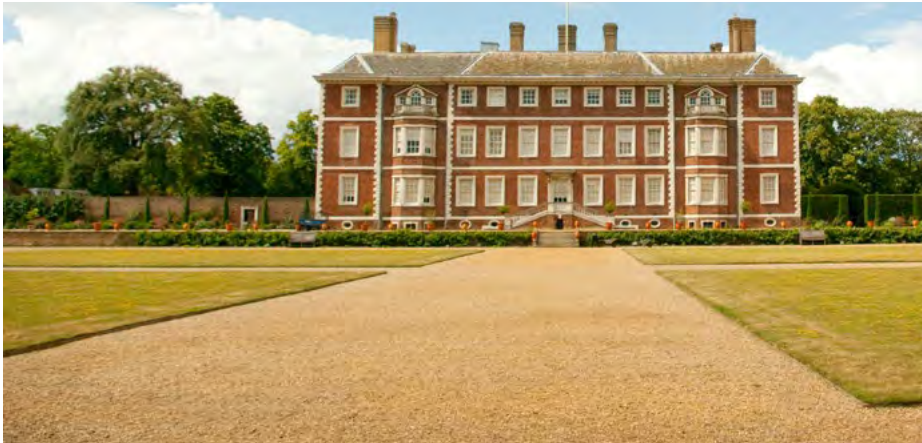
Loose gravel paths (such as those at Ham House, left) are tactile and yielding under foot. Gravel is naturally permeable, and it's drainage properties are more consistent in the long-term than self-binding gravel.

Over time, the underlying sub-base can become exposed, which can be rectified with additional gravel dressing.

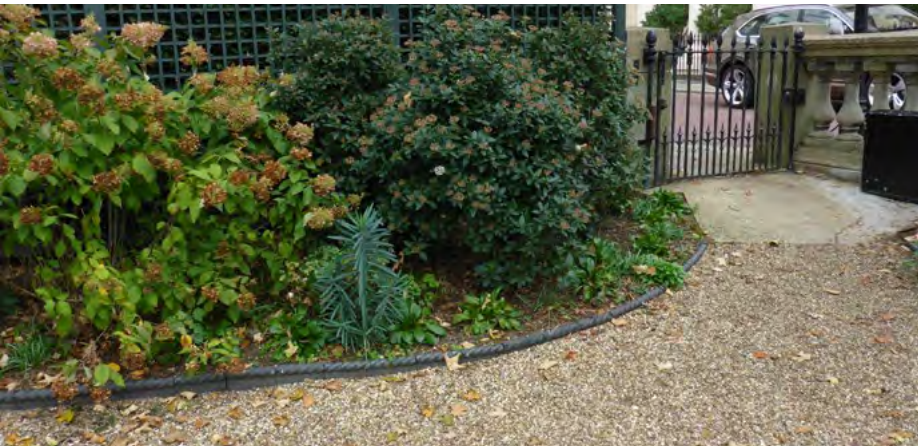
Rope edging is a common feature in most of the terraces and when installed correctly, provides an attractive and practical barrier for vegetation and gravel.

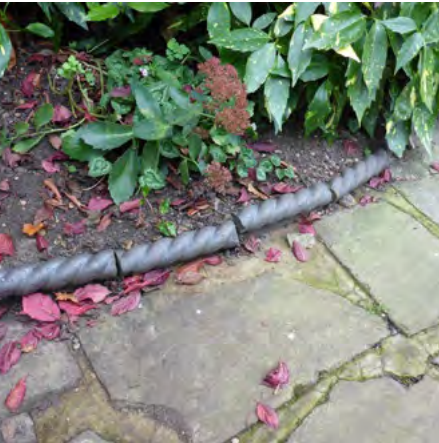
Far Left: Tight curves are hard to achieve using rope edging and therefore it is better suited to straight sections

Left: Timber is a low cost option for edging plant beds. Curved sections can be achieved by cutting kerfs into the inside face of the timber to allow the timber to bend.

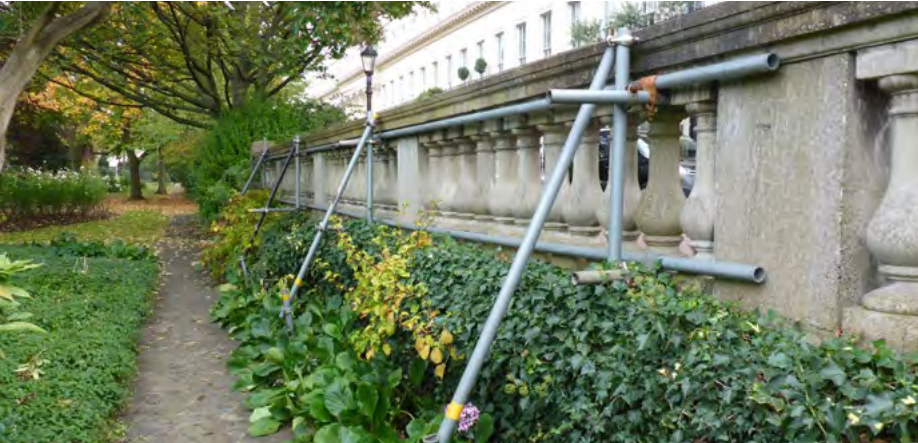
The existing concrete balustrade at Chester Terrace is in a poor state of repair and requires urgent refurbishment to ensure it is structurally sound.

The concrete balustrade on the east side of the garden is at risk of collapse in some sections and as a result a series of temporary scaffolds are in place to strengthen it. Investigations should be carried out into the structural stability of the existing retaining wall to determine the cause of the problems, and ensure there are not further issues effecting the wall itself. There are a number of possible factors effecting the wall, including increased vehicular traffic (and weight) along the carriageway, as well as the possible effect of tree roots on the original foundations.

Both the low parapet wall on the western boundary of the garden and the eastern retaining wall should be assessed by a qualified structural engineer to determine the nature and scale of refurbishment works required to each.

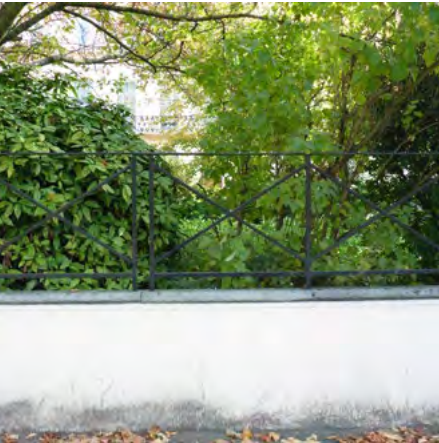
Far Left: The original cast iron railings were replaced in the 1950s with a simple modernist design.

The western edge of the garden is enclosed by a parapet wall and dwarf railings. In the 1950s, the early cast iron railings were removed and replaced with a modern design.

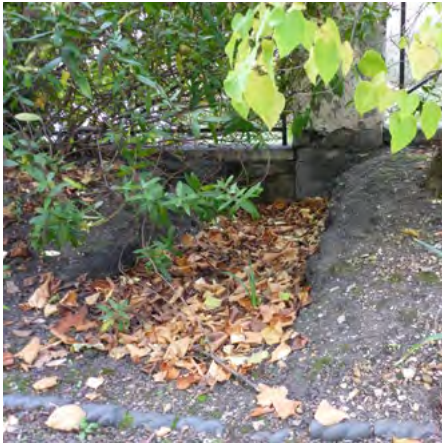
Left: Excavations at the south end of the garden illustrate the original soil level adjacent to the parapet wall.

As the garden has matured, the ground level adjacent to the parapet wall has risen (in part due to soil deposition through new planting). As a result, the boundary wall is now acting as a retaining structure despite not having been designed for this purpose. The additional pressure on the foundations will likely result in structural problems if not addressed.

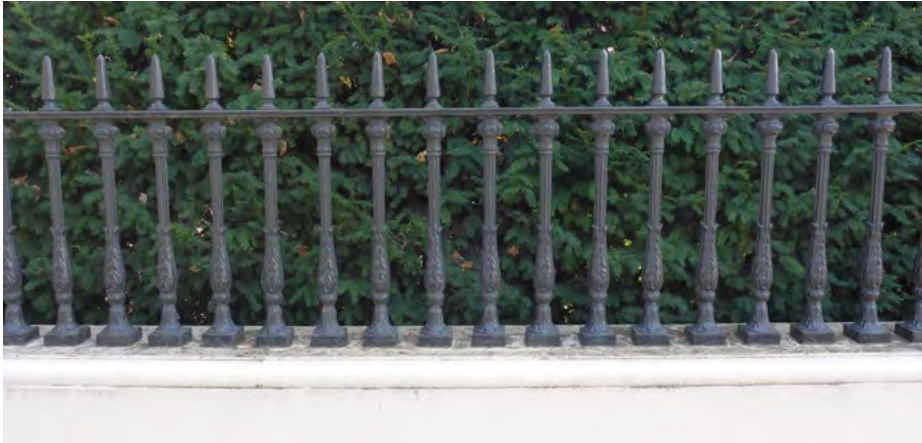
A section of the original dwarf railings are still present at the north end of Chester Terrace.

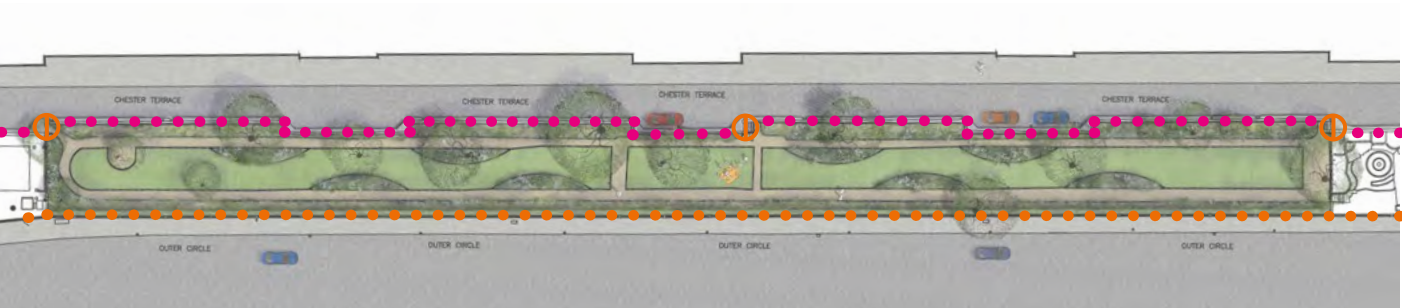
Proposed Railings Plan (NTS)

Following any structural repairs required to the retaining wall, a new composition stone balustrade should be installed that better reflects the original design and materiality. In 2012, a new composition stone balustrade was erected in Cumberland Terrace, which provides a successful precedent for Chester Terrace.

The soil level on the western boundary wall should be lowered to its original height, which will remove any additional stress currently placed upon it. Following any refurbishment works, new heritage style railings should be installed to match the original railing at the north of the site.
